**THE
CONCRETE
PIPE
ASSOCIATION
PAPER
SERIES
VOL. 1 NO. 3
D**

A Case in Point for Choosing Concrete Pipe **RIDGE LINE, INC. vs ADVANCED DRAINAGE SYSTEMS**

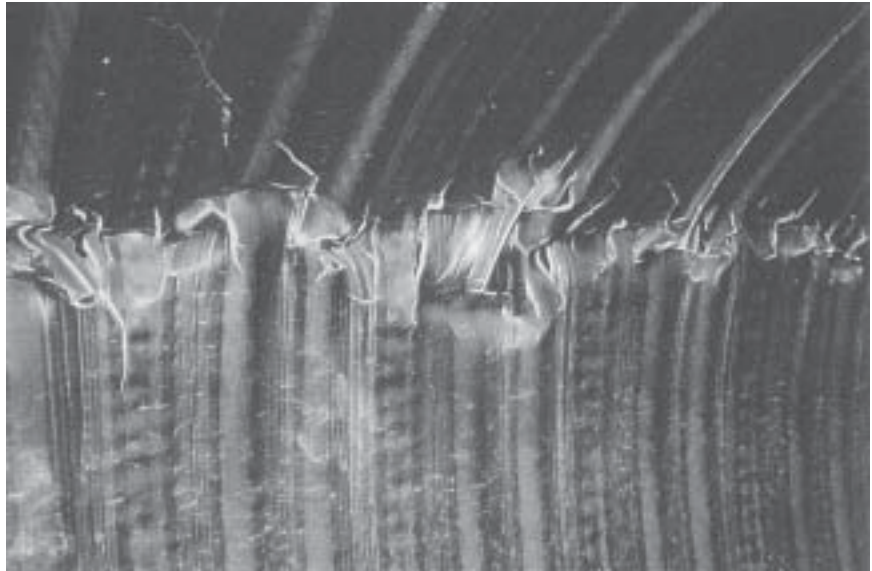
Six years after installation the pipe was found to be collapsing. The pipe was relined with a 36-inch pipe with grout between the two pipe walls. This resulted in insufficient drainage capacity for the site. Consequently, another pipe must now be installed to compensate for the lost capacity. The developer, Ridge Line, brought suit against ADS, who brought in by way of Third-Party Complaint, both Green Valley Bridge, Inc. and Triad Engineering, Inc.

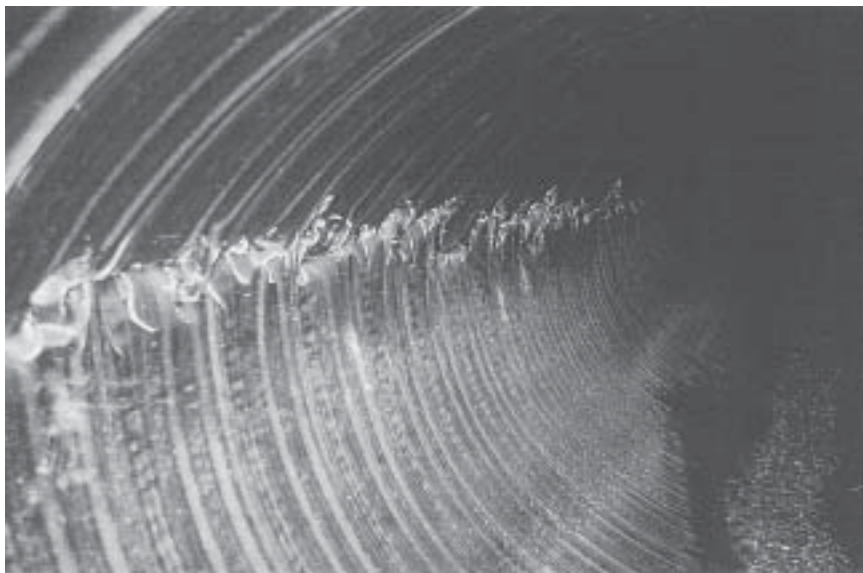
Many pipe manufacturers claim that their product can be installed like concrete pipe. But this is a false claim.

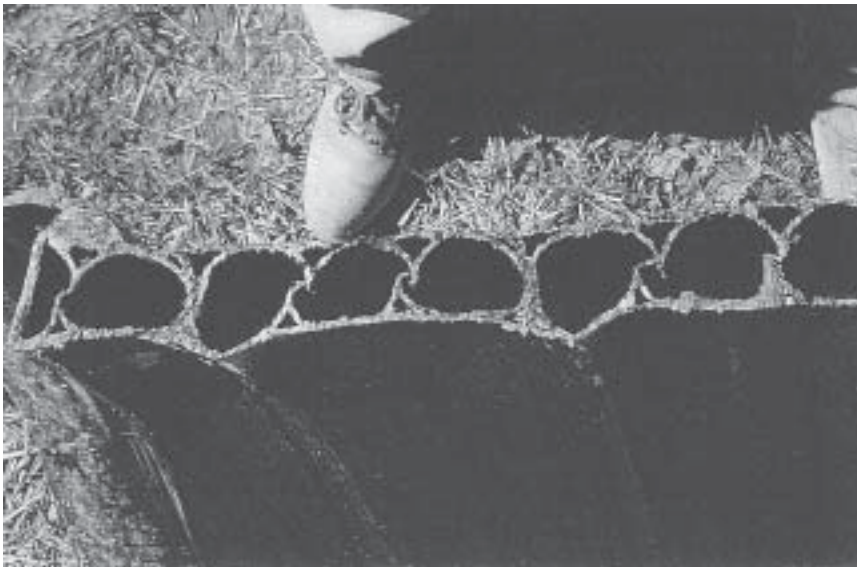
"Both ductile tearing and slow crack growth brittle cracking were prominent, accompanied by folding over of the damaged portions of the pipe wall"

equate for the customer's application. This wall profile is particularly prone to cracking and local buckling of the main load-carrying members. The cracking potential is increased by using a polyethylene material with low crack resistance and by tendency for distortion of the wall profile under loading. The cracking and distortion greatly increase the buckling potential. Furthermore, the polymer material used in the manufacture of this pipe is susceptible to cracking over time. In my opinion the combination of the pipe profile design and the pipe material is the cause of the failure."

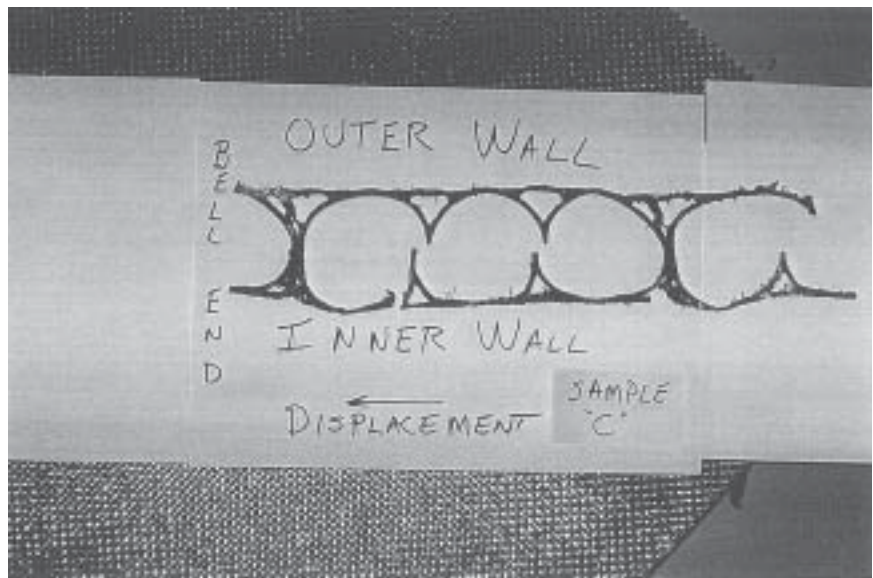
Ridge Line requested that ADS admit to the following: “Inspection of the product in January 2000, showed that the interior walls of the product had numerous defective conditions including but not limited to buckling and cracking.” Rather than owning up to the obvious, ADS responded: “ADS admits that inspections showed problems with the pipe related to poor construction and installation practices by the contractor and poor oversight by the owner.”
