Project 1 - US 27, Nicholasville Road, Lexington

Project 1 - SR 294, Harpster

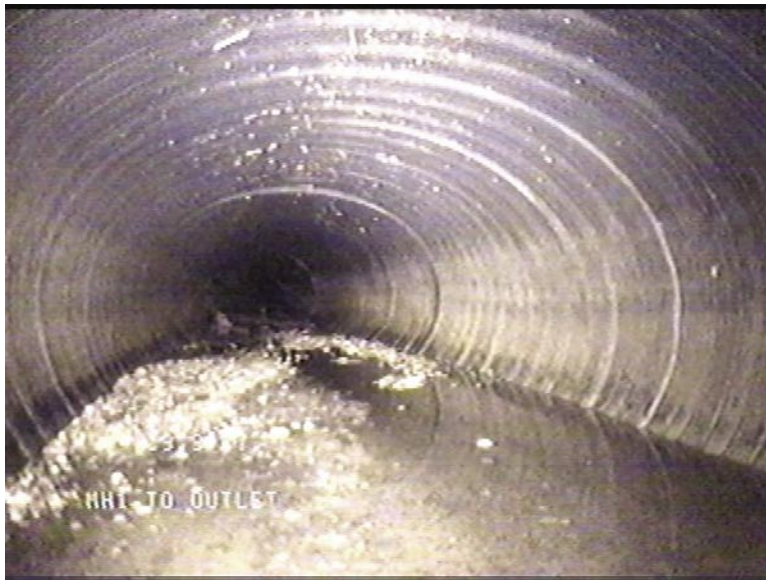
In July 2005, current visual inspection and laser deflection indicates that movement has occurred in several of the line segments. It is estimated that sections of the 24-inch outfall line are now deflected approximately 20%. The 36-inch cross drain near Moss Middle School is deflected approximately 13 to 14% near the inlet end in addition to signs of dimpling. Deflection readings taken by Wiss, Janney, Elstner Associates Inc. in 2002 indicated that that the pipe had deflected 11%, indicating deflections have increased within the last three years. Recent laser deflection data taken in 18 and 24 inch storm drains indicated average deflections between 5 and 10%. Radial cracking, invert and crown flattening, racking, and sagging is also observed in several of the line segments. Radial cracking is observed in approximately 24% of the pipe sections, and sagging is observed in 45% of the pipe sections. These developments were not observed in previous site investigations.

Video Image on Project 2, US 68/KY 80, showing approximately 20% deflection.

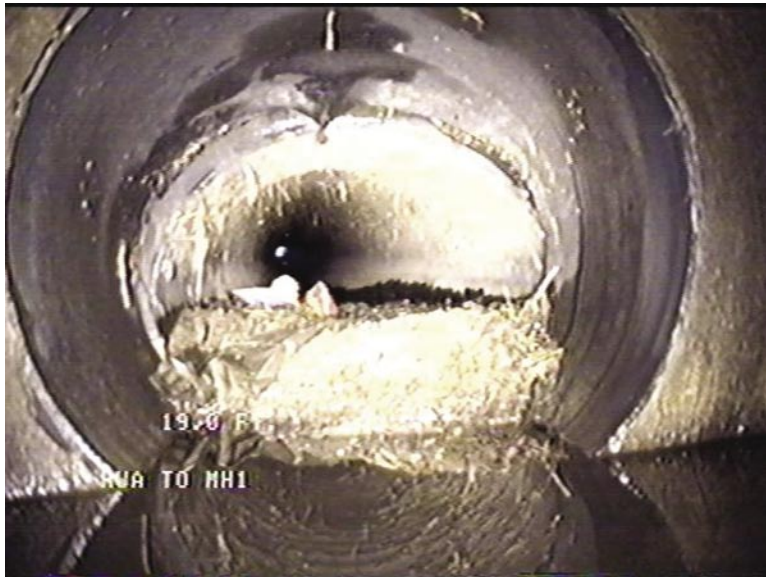
Video Image on Project 2, US 68/KY 80, with severe damage due to deflection and joint separation.

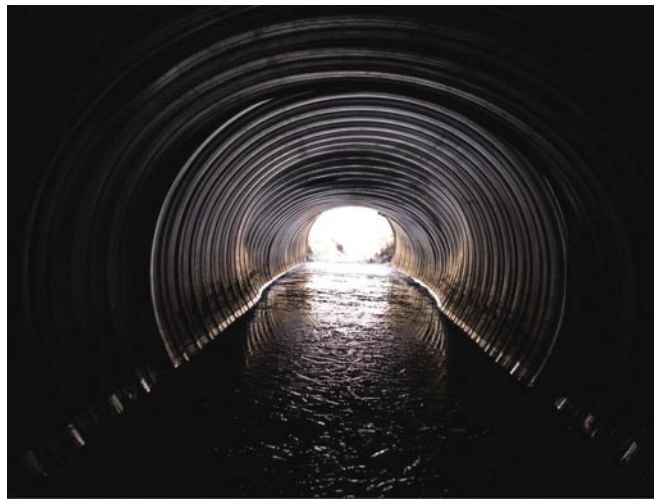
Wall buckling and dimpling were noted in the areas of deflection of 7.5% or greater. This was noted in the 2001 inspection and appear to have increased. Manual deflection measurements taken in 2005 indicate that the pipe has continued to deflect with a maximum deflection recorded in 2001 of 11.81%, and a maximum deflection of 15.63 % in 2005. Approximately 23% of the vertical measurements taken in 2001 would not pass a 5% deflection test and approximately 43% would not pass in 2005. Deflection readings indicate changes vertically and horizontally occurred near the outlet and inlet ends of the pipe. The 2001 report documented one crack, and seven cracks are documented in 2005.

Video Image on Project 1, Harpster, showing significant change in pipe deflection near outlet.

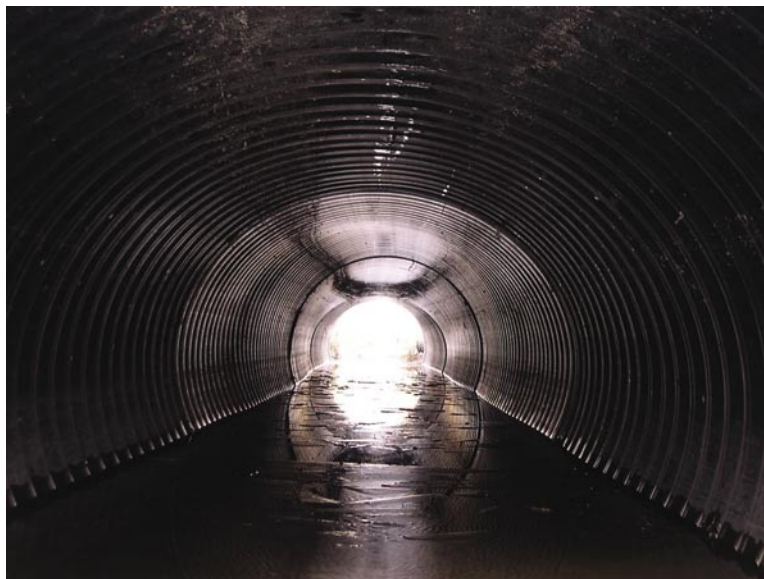
The 60-inch cross drain was installed in 1995 near Dola, Ohio, with a maximum depth of cover of 5 feet or less. The pipe was inspected in 2001 and on December 6, 2005. No buckling or dimpling is noted during the 2005 inspection. Manual deflection measurements taken in 2005 indicate that the pipe has severely deflected outside the roadway. Vertical deflection readings indicate that 53% of the pipe has deflected greater than 5%. Vertical readings were not taken in 2001. Crown flattening and racking is apparent in some areas. Cracking was not documented in 2001. One radial crack is noted in the 2005 inspection. Crown flattening is apparent at both the inlet and the outlet ends where deflections are near or greater than 10%. Creasing may be occurring at 10 and 2 o'clock where deflection is near 10%.

Video Image on Project 2, Dola showing vertical deflection and racking

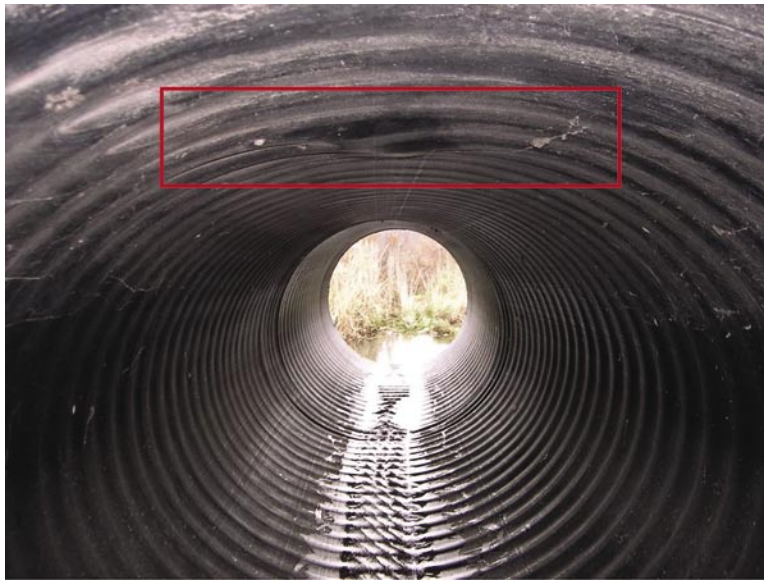
The 48-inch, 50-foot long cross drain was installed in 1999, under SR 661 near Homer, Ohio. The maximum fill height was approximately 2 ft. A bulge or buckle was reported in the crown of the pipe in 2001. It is apparent that the crown has continued to move since the last measurements were taken. Dimpling of the inner liner has occurred since the 2001 inspection and is observed from 30 to 40 feet around 10 o'clock. Dimpling is also noticed 39" from the inlet. In 2001 the vertical deflection at the bulge at 20 feet was 8.85%, and in 2005 it was 11.72%. In 2001, 9% of the vertical readings exceeded 7% deflection, and in 2005, 45% of the vertical readings exceed 7% deflection. Cracking is observed on the exterior of the pipe at the outlet end. No cracking is documented inside the structure. Corrugation creep of 3/8-inch to 9/16-inch is observed. Heavy corrugation creep is also evident from the laser profiles.

Project 10, Homer, showing bulge in crown

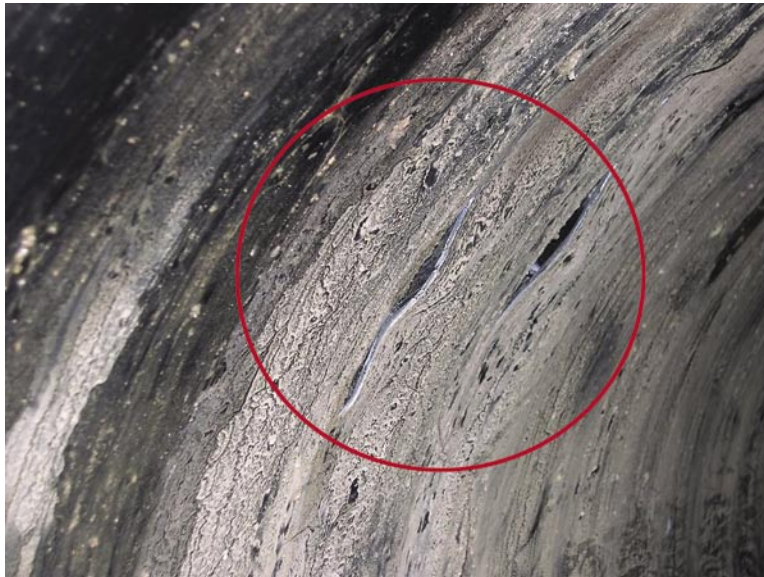
Project 10, Homer, showing cracks in pipe wall above spring line
