An educational document from the American Concrete Pipe Association for users and specifiers

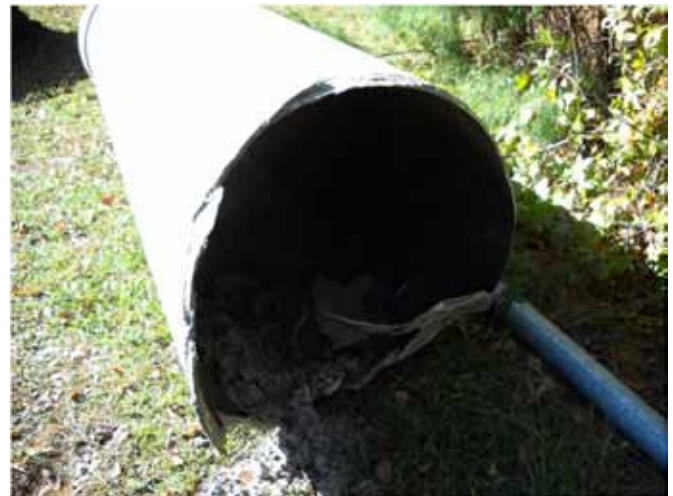
Sections of Brighton Road in Brookings, S.D. caved in twice in 1996 because of a cracked FRP sewer line that had been installed in 1979. Both cave-ins caused craters, the first resulting in personal injury. It was determined that prematurely cracked pipes leaked (infiltration / exfiltration), causing erosion of the backfill which resulted in a road collapse. Subsequent to the road closures, the sewer line was examined with a mini-camera. Cracks appeared on the top of the FRP pipes and allowed earth and gravel to infiltrate into the sewage that was pumped to the city's wastewater treatment plant. About 4,500 feet of FRP pipe had to be replaced by the City at a cost of about \$600,000.

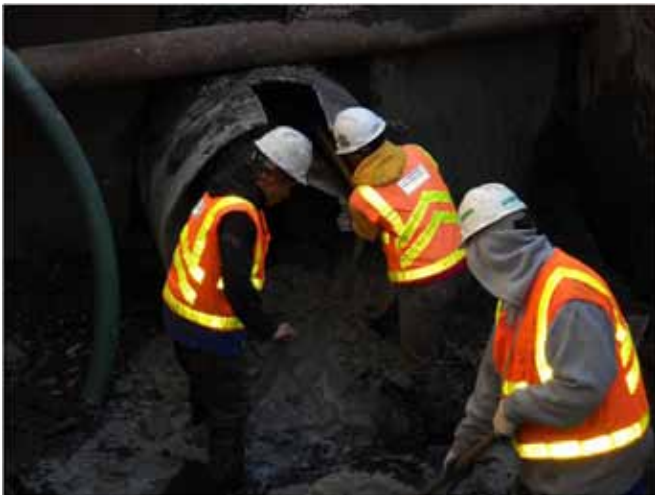
Some history appears to be repetitive. Failures along a 9,000-foot section of the 36-inch diameter FRP Ogden Interceptor sanitary sewer in New Hanover County N.C. (Cape Fear Public Utility Authority), occurred in 2008, 2009 and 2010.² The interceptor was built in the late 1990s to help ease demands on the Northeast Interceptor by drawing flow from the line and the City's Southside wastewater treatment plant, thereby increasing overall capacity to allow more development. The failing line carried two million gallons a day. Some spilled into Smith Creek when emergency bypass pumps failed.

After assuming responsibility for the repair and replacement project, The Cape Fear Public Utility Authority had to cut funding or delay millions of dollars' worth of projects to pay for the emergency repairs and replacement. This affects several projects, including new sewer pipes in unserved areas, rehabilitation of old sewer pipes, and construction of new water lines. In addition, \$8 million had to be set aside in a reserve fund in case of other emergencies. The emergency replacement with ductile iron pipe cost \$7 million.
