FLOTATION (BUOYANCY) COMPARISON

American **Concrete Pipe** Association

Flotation (Buoyancy) Comparison: Concrete vs Flexible Pipe

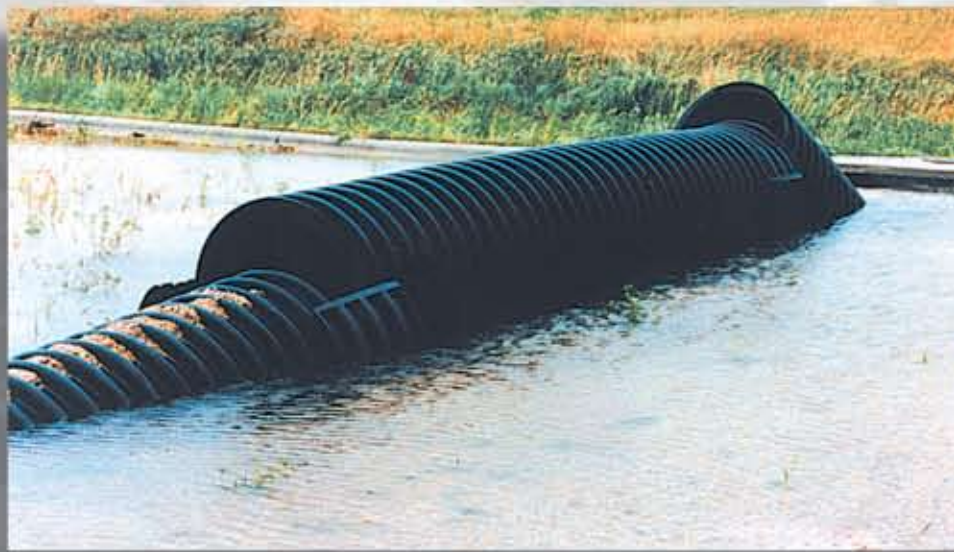
Saukville, WI

After completion of the site work for a Wal-Mart store, a portion of a line of 36-inch diameter corrugated polyethylene pipe with an interior liner floated out of the ground. This line was part of the parking lot drainage. The pipe had approximately one foot of cover. Fortunately, the pavement had not been completed at this time.

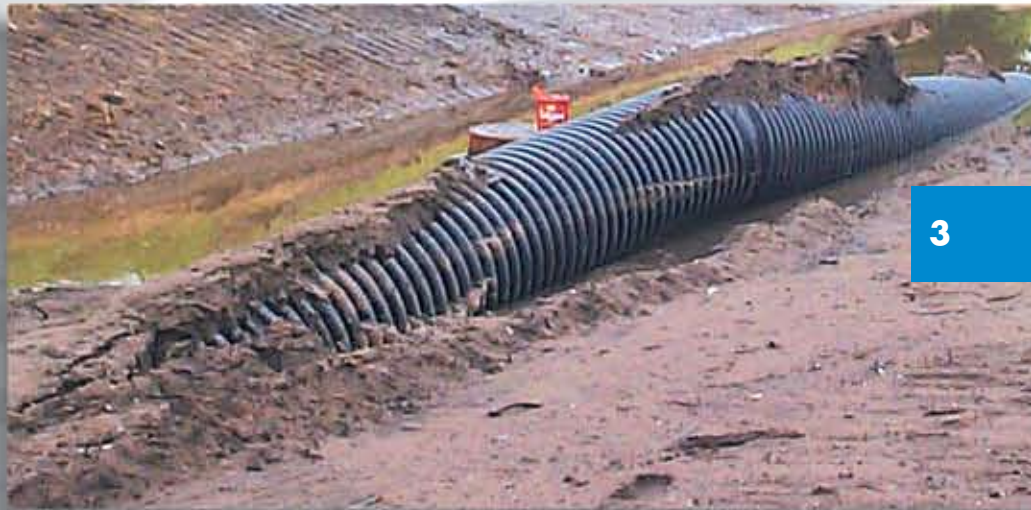
St Paul, MN

The pipe used in a ditch realignment project was 24-inch diameter corrugated polyethylene pipe with interior liner. Although the pipe was installed parallel to the ditch and with two feet of cover, two sections of the pipe floated out of the ground after a day of steady rainfall.

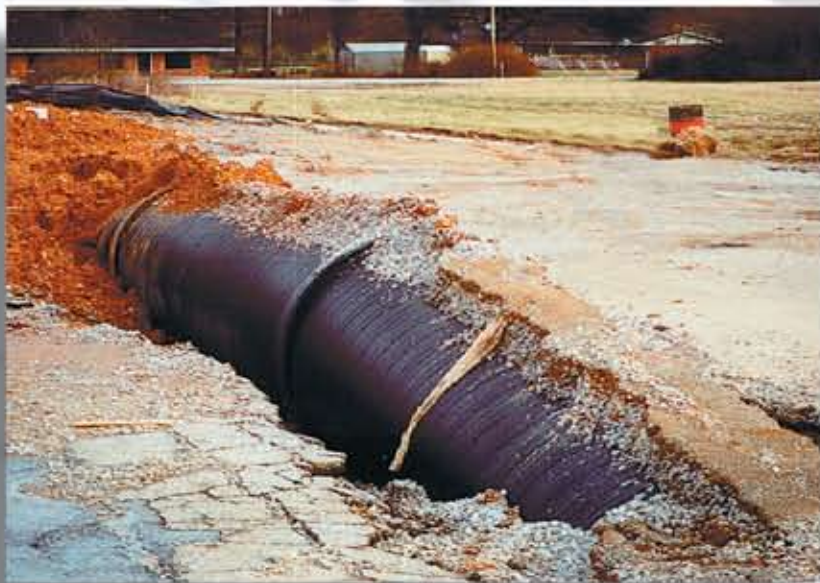
Chattanooga, TN

Even though it was full of water and had a cover of 12 inches of crushed stone, a 48-inch diameter corrugated polyethylene pipeline floated out of the ground three times. When the developer revealed plans to use HDPE pipe in lieu of concrete pipe, the engineering firm requested in writing to be released from any responsibility and liability. Therefore, the expenses of reinstallation of the HDPE pipe were borne by the developer and the contractor.

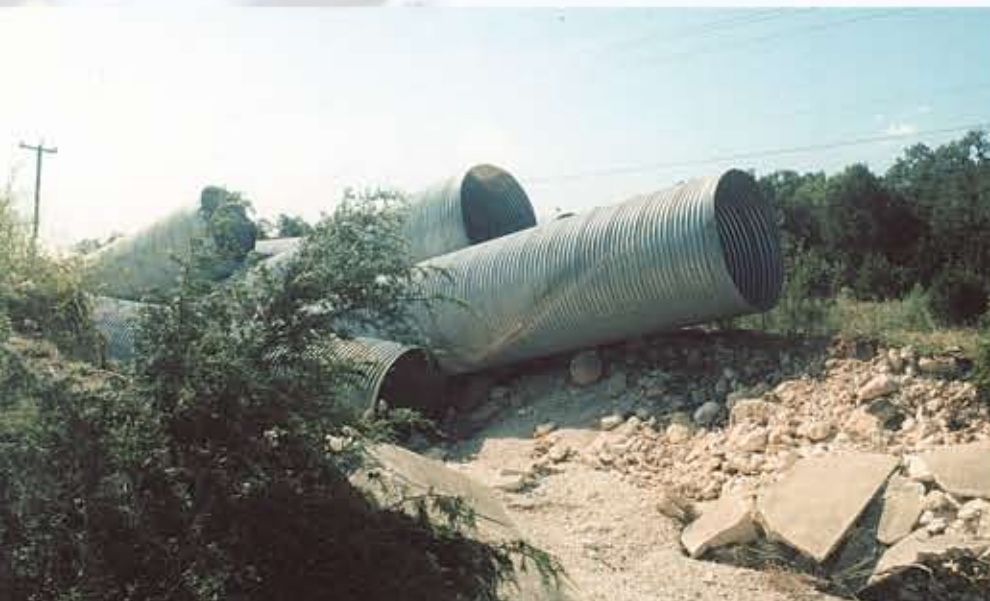
San Antonio, TX

A few hundred feet of a double 108-inch diameter corrugated metal pipeline floated completely out of the ground after heavy rain. The pipe, which received water from a ditch with a paved inlet, had approximately two feet of cover.
