An educational document from the American Concrete Pipe Association for users and specifiers

### Design-Installation Failure of the Corrugated HDPE Pipe System

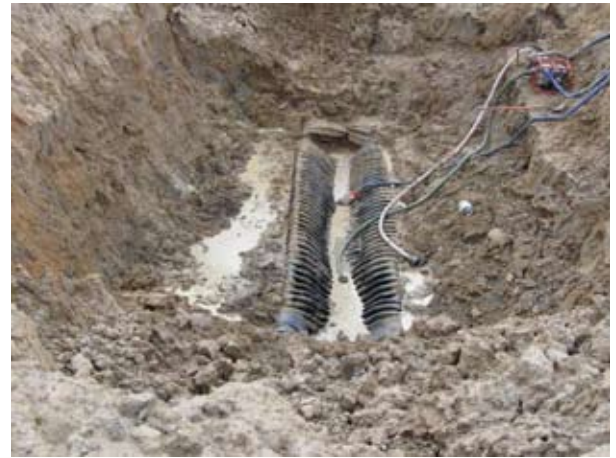
In April 2009, inspectors at the John D. Parker East Texas Fish Hatchery discovered that sections of 60-inch and 48-inch diameter high-density polyethylene (HDPE) drainage pipes had collapsed.<sup>1</sup> Ultimately, approximately 11,000 linear feet of 30-inch, 48-inch, and 60-inch diameter corrugated HDPE pipe were removed and replaced.
